BLOOMINGTON HISTORIC PRESERVATION COMMISSION

**Showers City Hall
McCloskey Room
Thursday June 9, 2011
4:00 P.M.
AGENDA**

Preliminary Review COA

714 West 7th Street
Fairview Historic District
Eve Mansdorf

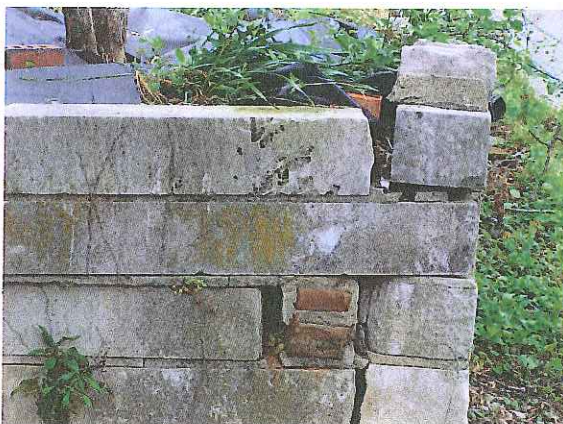
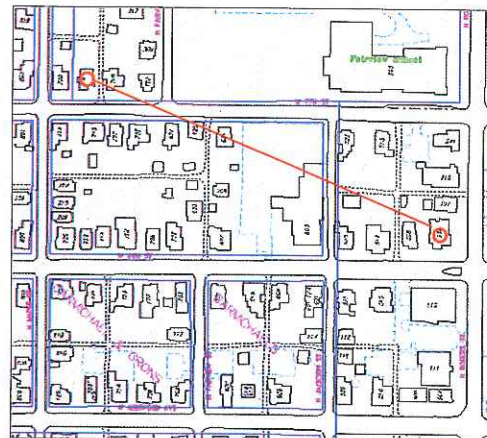
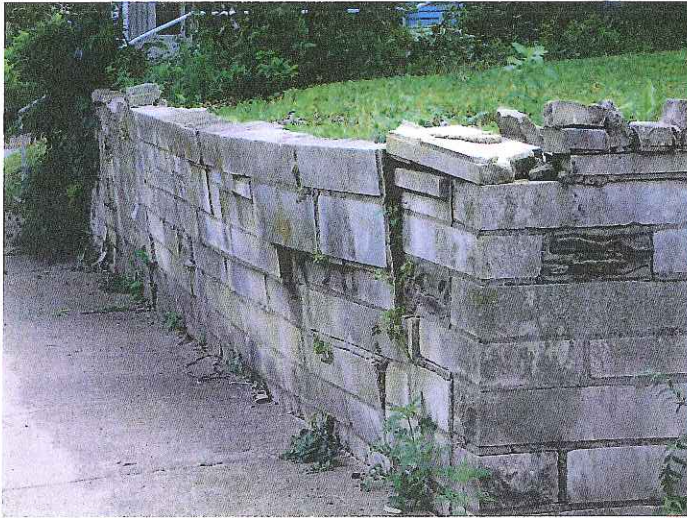
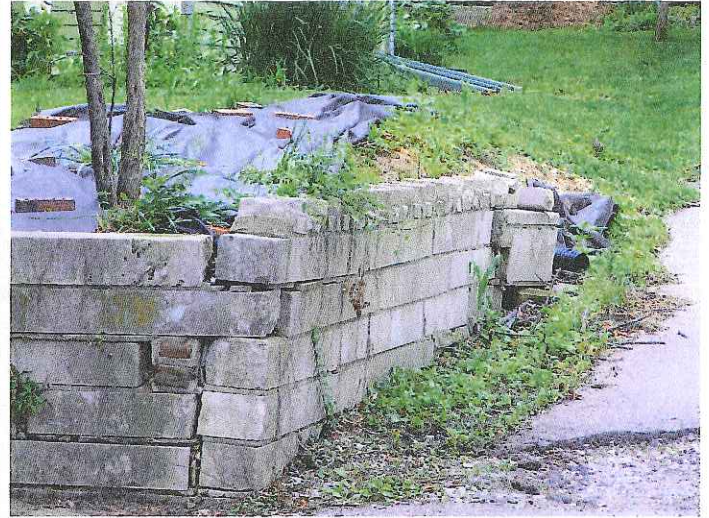
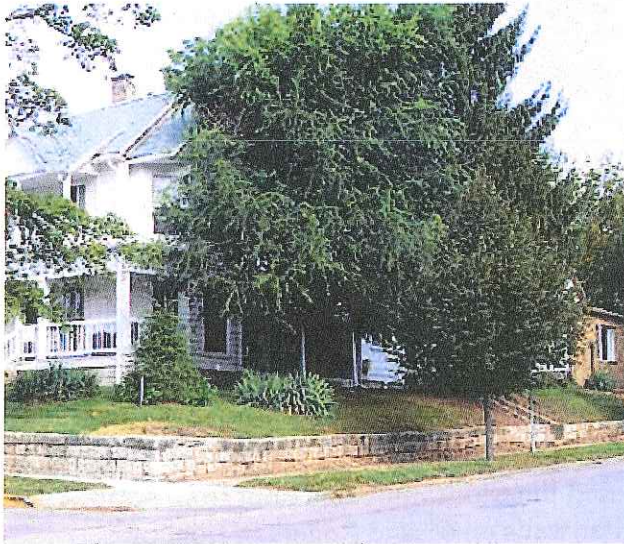
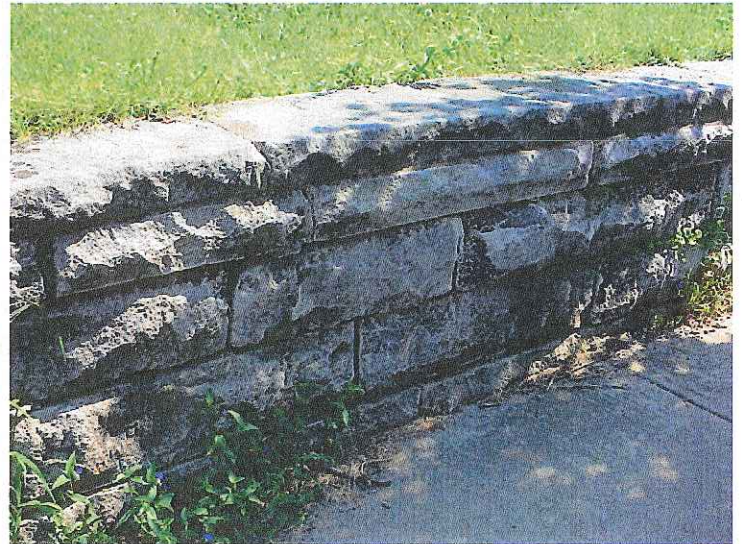
The owner will present information about a deteriorating retaining wall in her front yard. She has spoken with an engineer, assessed the damage and potential methods of repair. The plan for the wall repair will change the look of it. The following photographs are for documentary use.

Existing conditions: The wall is mortared dressed limestone, probably built from scrap that dates from after the house was built. Similar walls on 6th and Rogers in front of comparable homes are constructed of rock-faced limestone, some with tool marks. An item of significance for this wall is the partial row of vertical teeth used on the capstone. This wall is not continuous with neighboring properties. It is the only wall on this side of the street. It is in very deteriorated condition, as the photographs show. The section west of the stairs and along the alley indicates imminent failure.

The owner would like to discuss her plans for repair. Staff makes no recommendation until after formal application is complete.

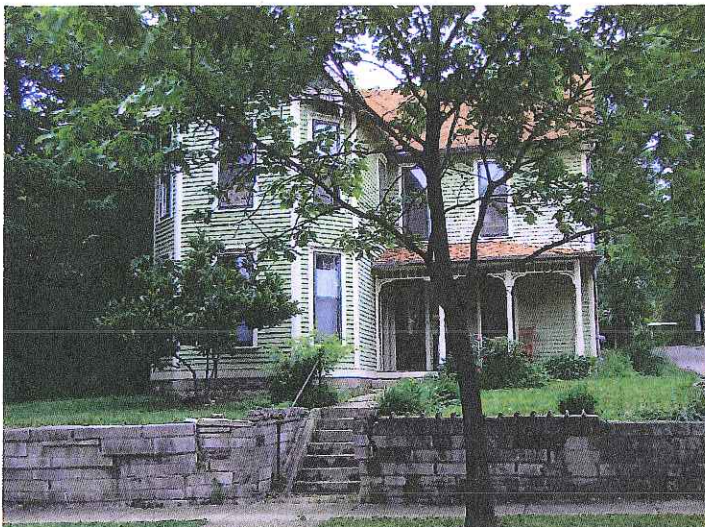
Above: Rock-faced wall nearby in the neighborhood (502 West 6th) of a comparable era.

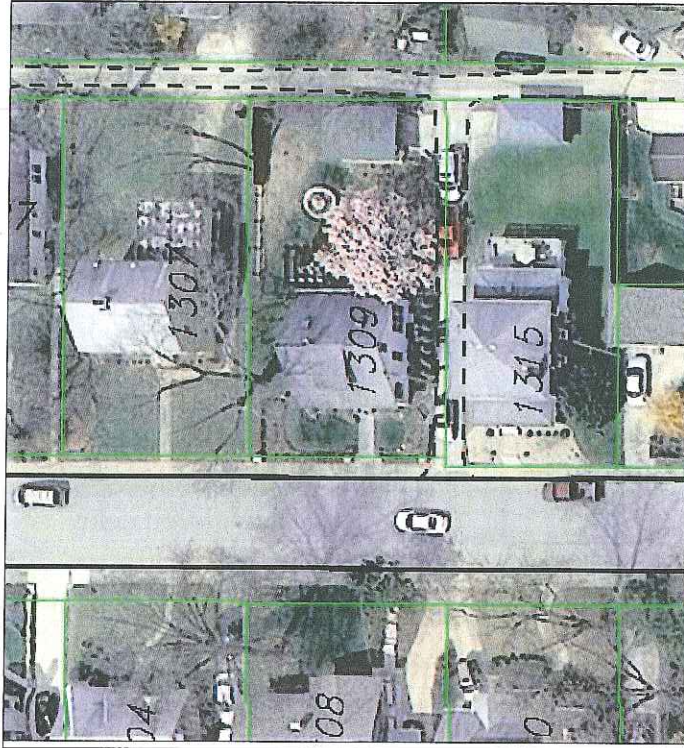
This is a brick bungalow with arched porch and central symmetry. The porch roof slopes continuously from the main gable and contains a paired window shed roof dormer. The dormer is not original. The owner attended the March meeting of the Commission to discuss their plans for a large addition. The lot is slightly substandard and is constrained by a shared driveway on the east and a large tree on the west. The streetscape is fairly congested with closely spaced housing at this location.

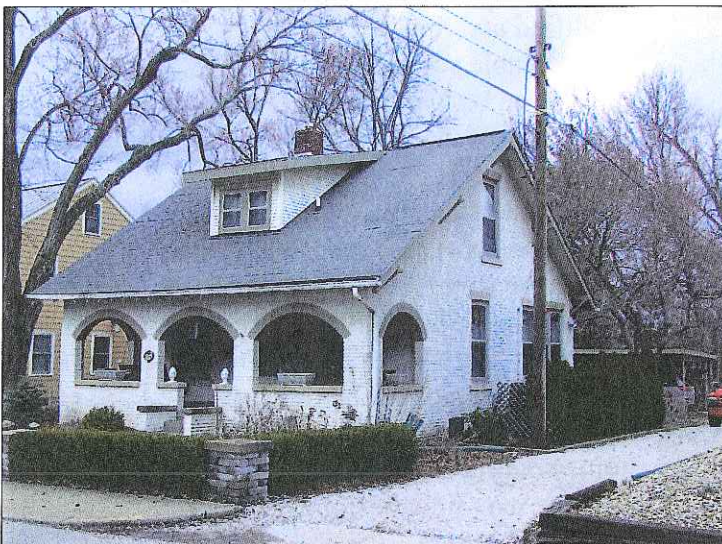
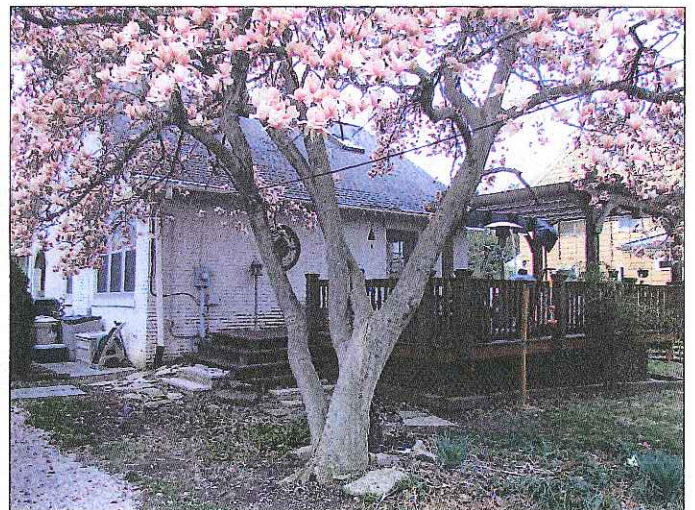
Rear: Location of addition.

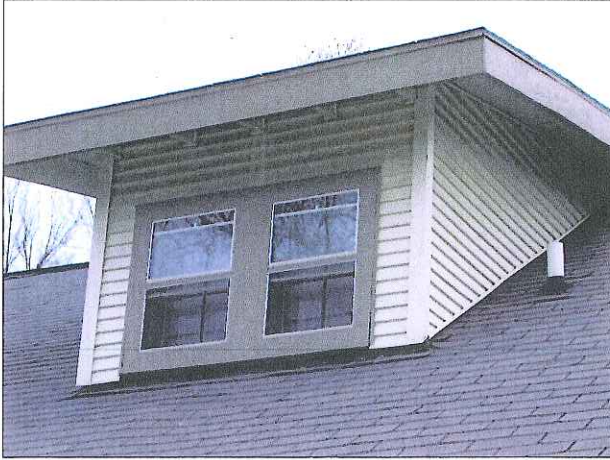
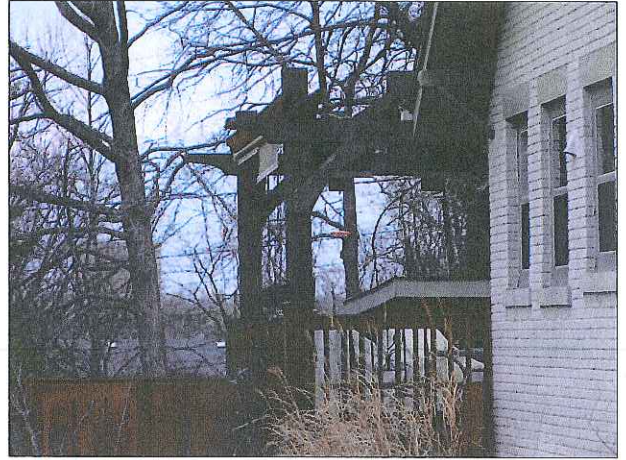
Existing Front Dormer- not historic

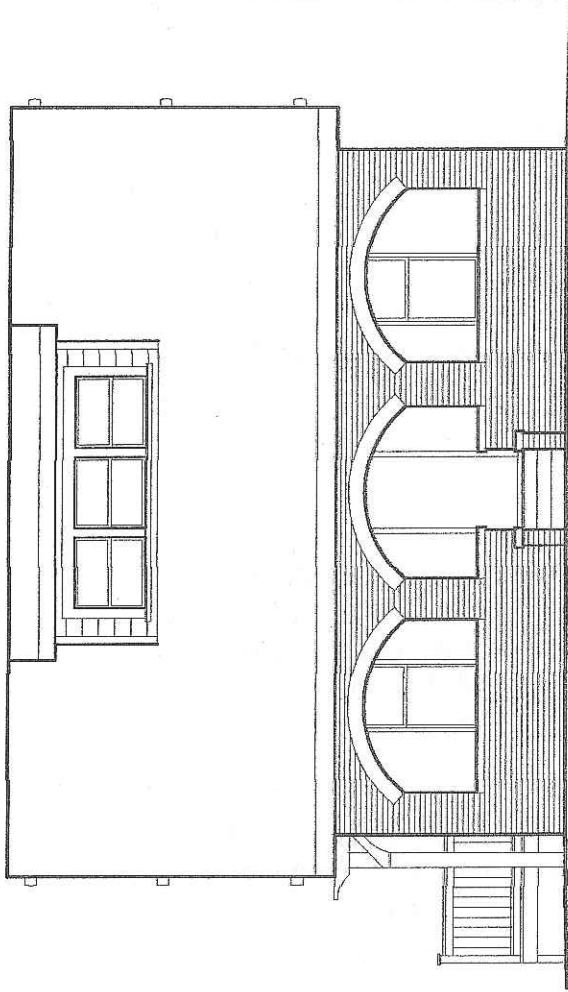
SOUTH ELEVATION
SCALE : 1/8" = 1'-0"

At its April meeting, the commission asked for additional information to ascertain the dimensions of the trim. Chad Vencel, representative for the owner submitted scaled plans for the addition. The cement board headers will be 8 inches and the window trim 4". The number of windows on either side elevation has been reduced. They have selected double hung aluminum clad windows. The scaled drawing shows a shed dormer in good proportion to the porch and the entry.

The design reflects the Commission's suggested modification of building the addition to the rear, offsetting the brick main body 6 inches and slightly lowering the shed roof on the winged dormers. The cement board siding will have a 7 ½ inch reveal.

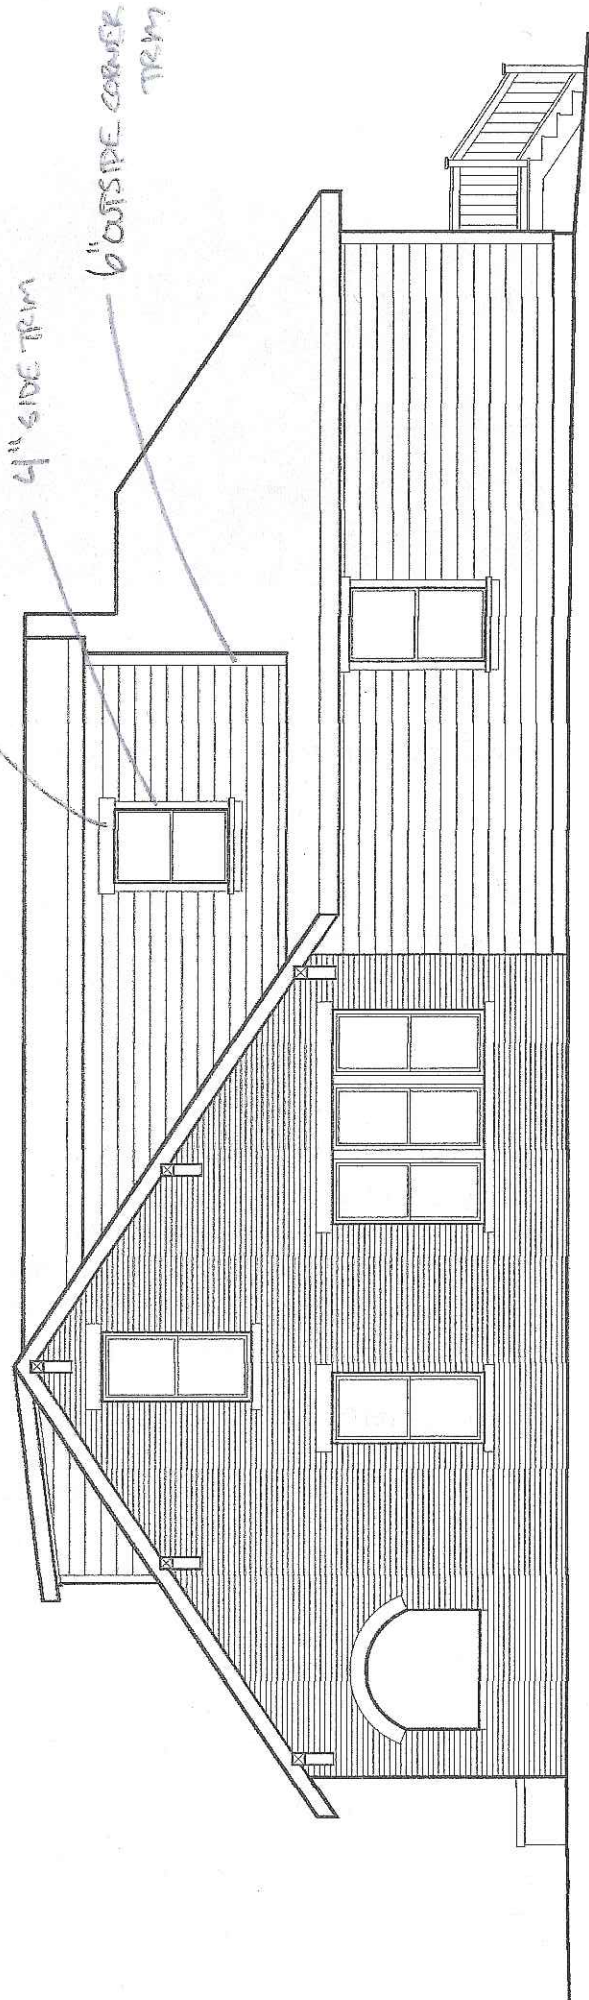
EAST ELEVATION
SCALE : 1/8" = 1'-0"

The two story addition is about 29 x 18'. The addition roof, brought off the rear of the house, steps down to a hipped single story addition (18x17'). The two story level is designed with paired dormers winging away from the gable.

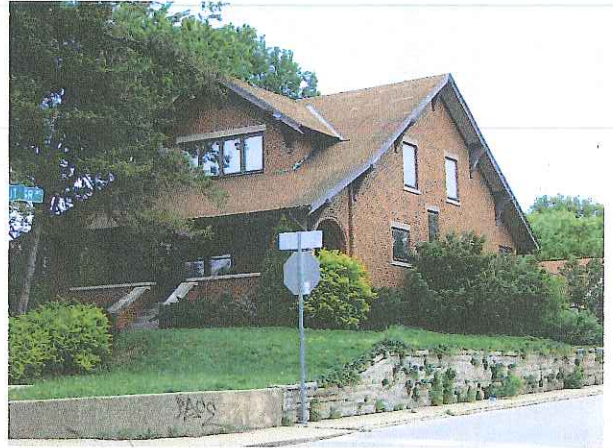
Existing Conditions:

The house is fair to good condition. Most windows are original and are a less frequently used Arts and Crafts design; however they are largely obscured by mirror glass storm windows. The material is tapestry brick which is also less common in Bloomington and is more prevalent south of Grimes except on the commercial buildings built by the Mitchell Brothers.

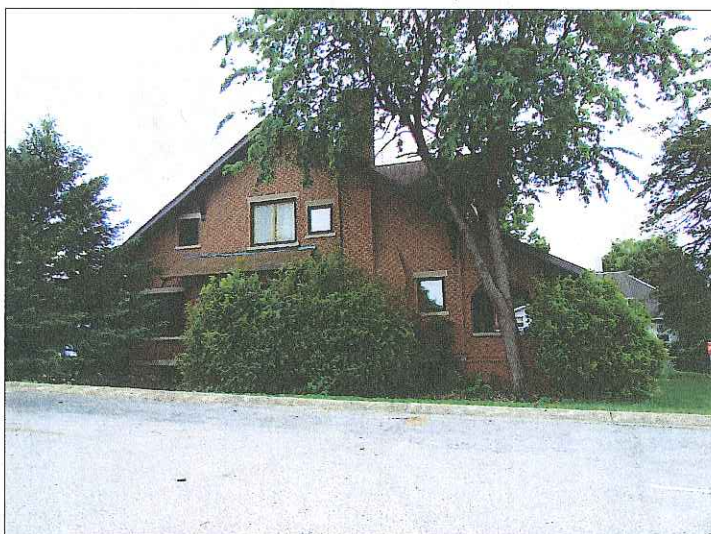
This is an early discussion of the possibility of moving a house on Walnut Street to another location. The house sits on the corner of Cottage Grove and North Walnut Street which is a commercial corridor

where many single family houses have been converted to business use. Although there are modern intrusions, the corridor has a fairly consistent run of these homes from the 400 block through the 800 block ending just below the Indiana Railroad viaduct. This represents properties listed as contributing to the Illinois Central survey district, North Washington and Cottage Grove, and some scattered sites. The actual location of 700 North Walnut is just south of the Highpoint Office Park, a single story commercial strip center built in the 1970's on the site of the old Hunter House. On the east side of the
